Stopping Heat With Therma Sheet!

Therma Sheet™

Metal & Concrete or Clay Tile
Roofing Underlayment

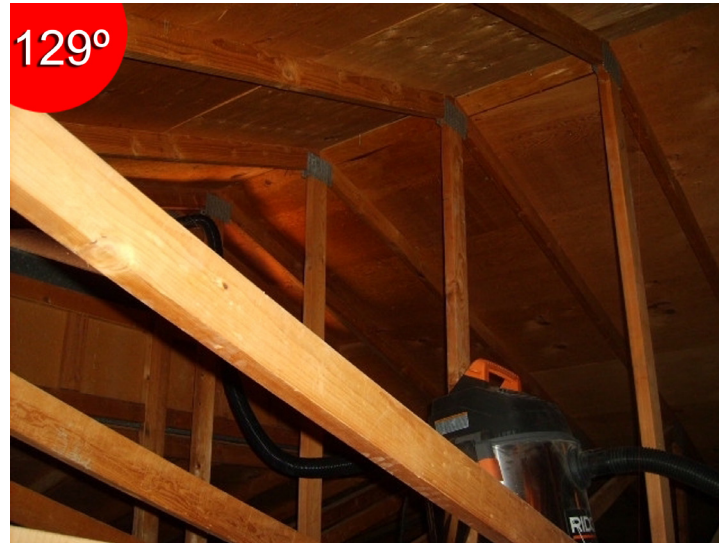
4/7/09 Existing roof before replacement. Span of IR image rset at 100-130°F for optimum image quality.

The attic space was shot on separate days at the same time and temperatures. The first IR photos were taken before the cement tile roof was taken off on April 7th 2009 at 11:00 a.m. The outside temperature was 92°.

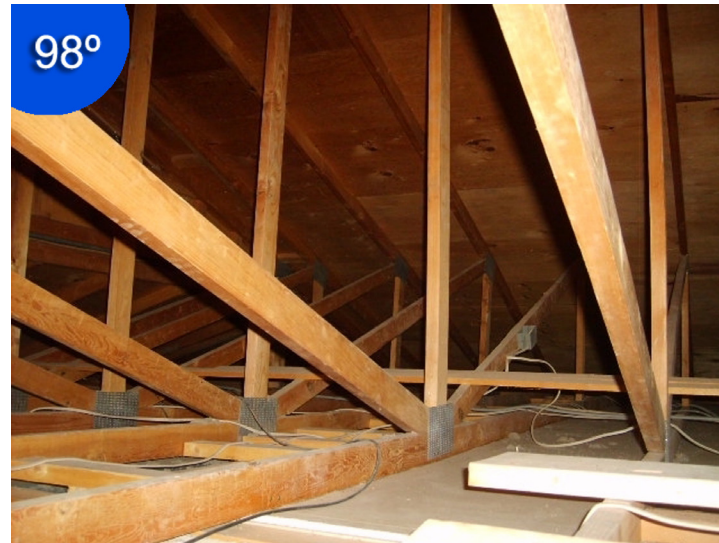
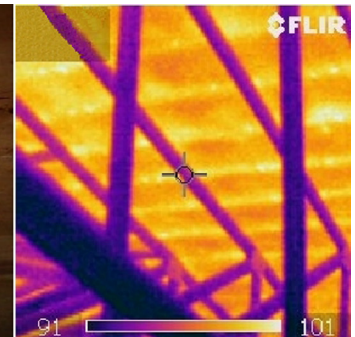
5/13/09 New roof tile over Therma Sheet. Span of IR image reduced to 91-101° F to match original 4/7/09 image. Attic temperature has been lowered 30°F with the addition of Therma Sheet.

The 2nd IR photos were taken on May 13th 2009 at 11:00 a.m. after the completion of the job. The outside temperature was again 92°. With the addition of Therma Sheet Underlayment the attic temperature was reduced a minimum of 30 degrees!!!
